TECHNICAL REPORT BRL-TR-3191

POWDER PACKS—
A PASSIVE APPROACH TO EXTINGUISHING
FIRE IN COMBAT VEHICLES

ANTHONY E. FINNERTY
STANLEY POLYANSKI

JANUARY 1991

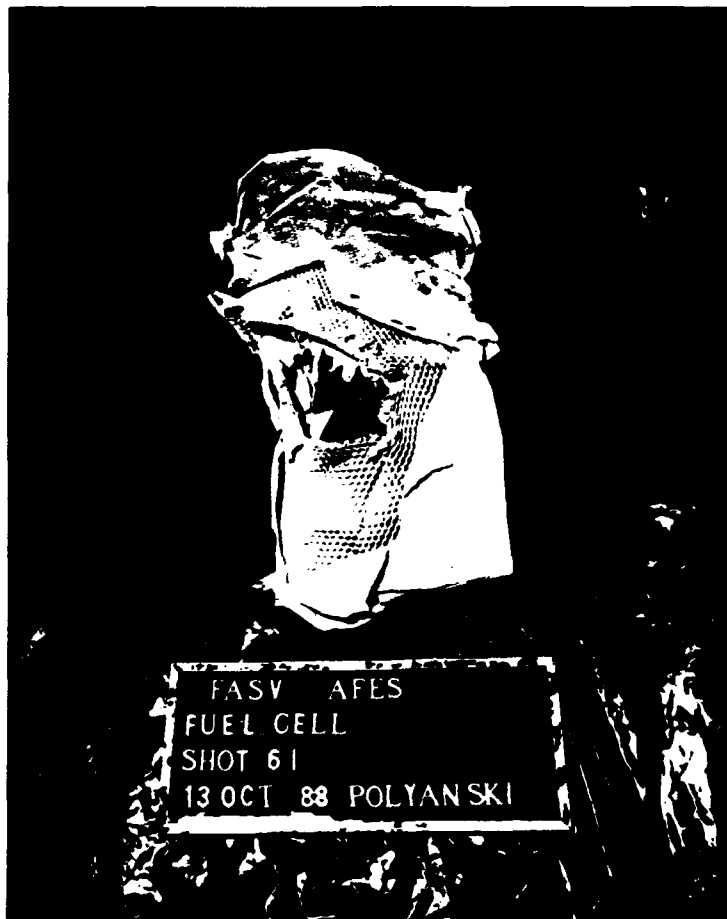
Figure B-6. Powder Pack After Second Fuel Shot.
